S-210 Carrigan Farm Near Dublin Private

Maryland Historical Trust State Historic Sites Inventory Form

1. Nan	ne (indicate pr	referred name)		
historic Car	rigan Farm			
and/or common				
2. Loca	<u>ation</u>			
street & number	North Side of M	itchell Road		not for publication
city, town	Dublin	X vicinity of	congressional district	First
state Maryla	and	county	Somerset

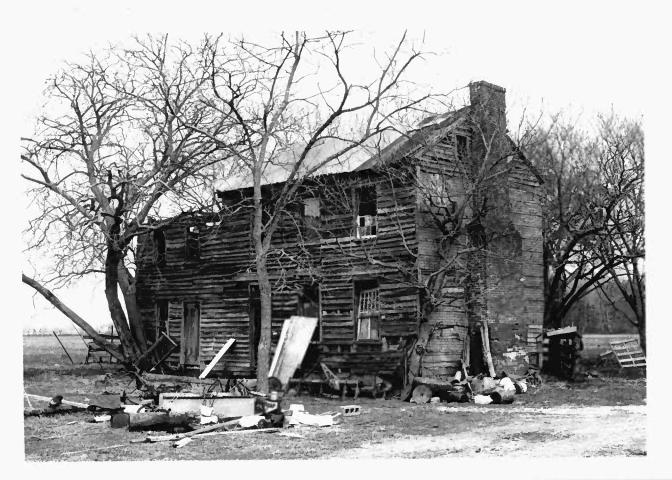
Carrigan Farm
Near Wellington, Somerset CountyNorthwest Elevation
5/84 Paul Touart
Neg./ Maryland Historic Trust

The west gable end of the main block has an exterior 6:1 common bond brick chimney with corbelled shoulders at the second floor height. A layer of imitation brick asphalt siding partially covers the west gable end. Two small attic window openings flank the stack.

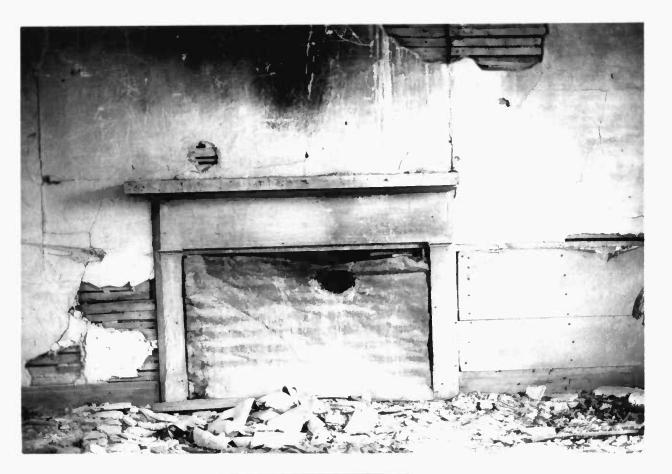
Carrigan Farm
2nd Floor Mantel
Near Wellington, Somerset County
5/84 Paul Touart
Neg./ Maryland Historic Trust

The second floor is divided into a bedroom and a small room at the head of the stairs. The attic stair is located in this small room. A one-panel door encloses the small stairway. The bedroom is simply finished with lath and plaster. A plain post and lintel mantel survives on the end wall.

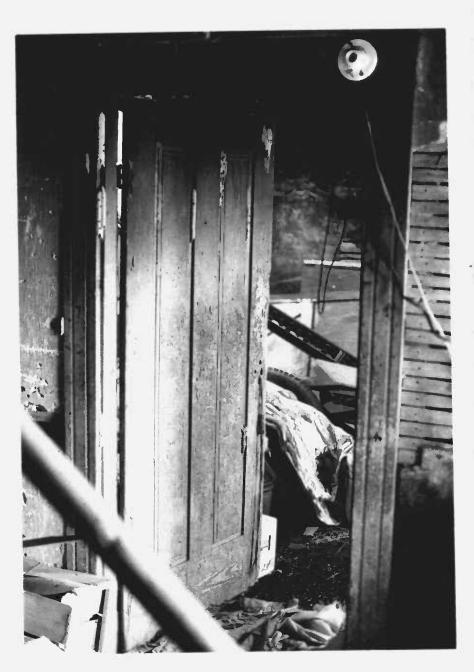
Carrigan Farm
Parlor Door
Near Wellington, Somerset County
5/84 Paul Touart
Neg./ Maryland Historic Trust

Inside the main house, the walls are plastered with riven oak lath fastened by cutnails. A dog-leg stair rises in the southeast corner. A slender square newer post a square balusters support a circular-profile handrail. A two-panel Greek Revival door framed by a fluted surround with corner blocks. The door opens into a nearly square parlor with end wall hearth. The plain post and lintel mantel has been removed from its original location.
